**APEX HOME INSPECTIONS, INC.**

# HOUSING INSPECTION REPORT

DATE: January 23, 2021

PROPERTY ADDRESS: 149 Circle Drive Manhasset, NY

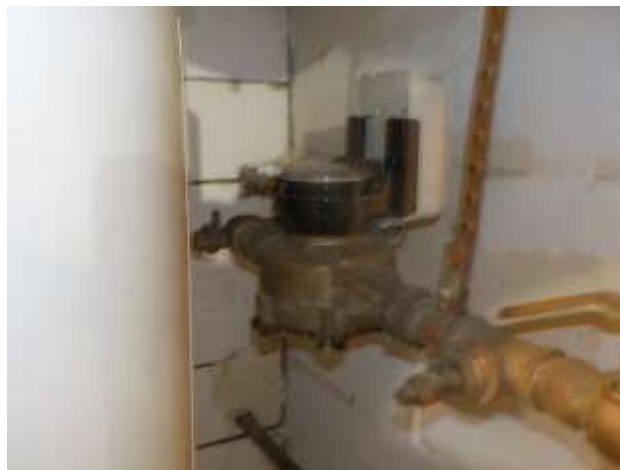
The water meter and the main water shut off valve are located on the south side of the basement behind the boiler; there should be a ground wire attached to ground the home for your protection, if one is not present one should be installed. It is recommended that you upgrade to a ball valve for a quicker and easier way to shut down the water supply in the event of an emergency if one is not present. Any hidden defects are the sole responsibility of the potential home buyer, this inspection is based on visual access only. A licensed plumber and a licensed electrician should be contacted to make all needed repairs and upgrades for you.

WATER METER AND MAIN WATER SHUT OFF

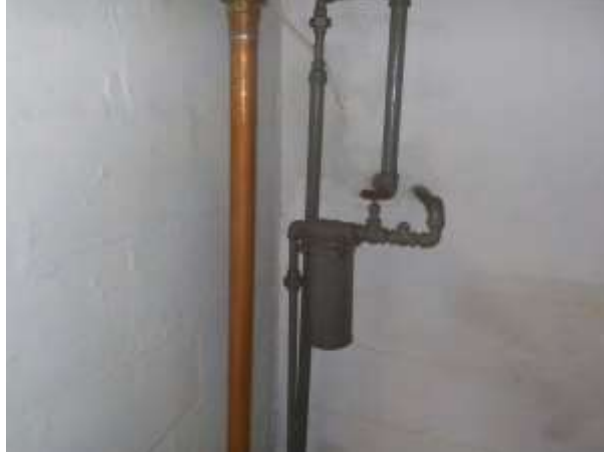
well pipe which appears to be cut and capped, further evaluation is needed. Any hidden defects are the sole responsibility of the potential home buyer, this inspection is based on visual access only. A licensed plumber should be contacted to inspect the entire plumbing system and to make all needed repairs and upgrades for you.

WELL

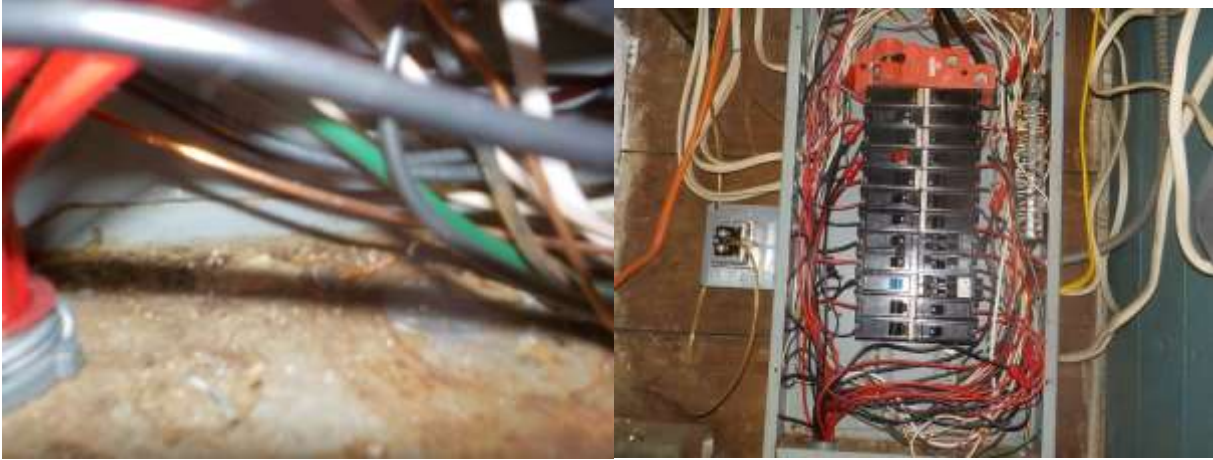
3. Insulation and a vapor barrier are needed in the crawlspace on the south side.
4. There is evidence of moisture in the electric panel, which is a fire hazard, replacement is needed.

OVERALL VIEW OF PANEL, RUST, DETERIORATION, CORROSION

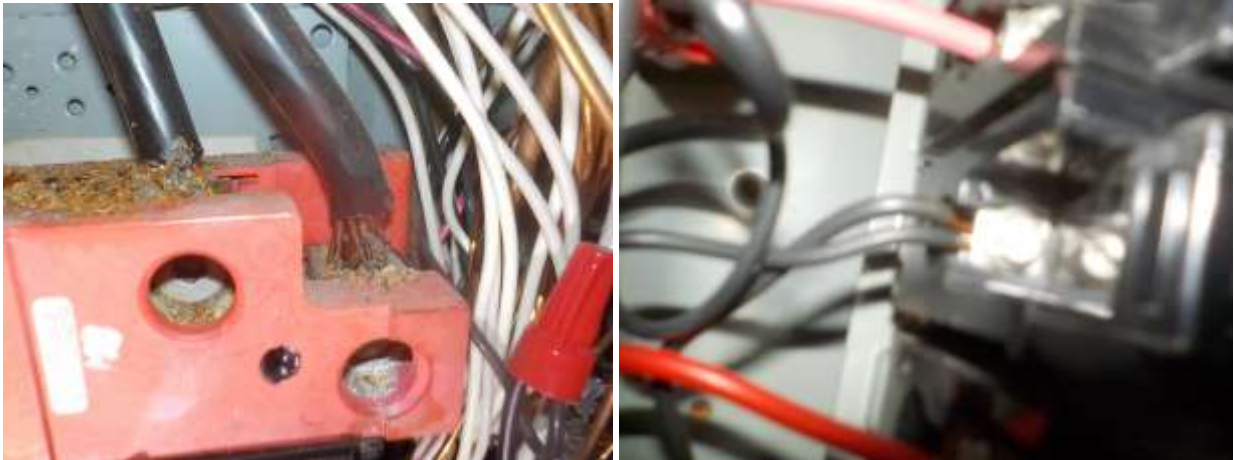
8. There is a double tap circuit breaker in the electric panel, this is a safety and fire hazard, repair is needed.
9. GFCI rated outlets are needed in damp areas, see Interior and Exterior Electrical Addendums for further information.

CORROSION TO LUG NUTS AND DOUBLE TAP CIRCUIT BREAKER

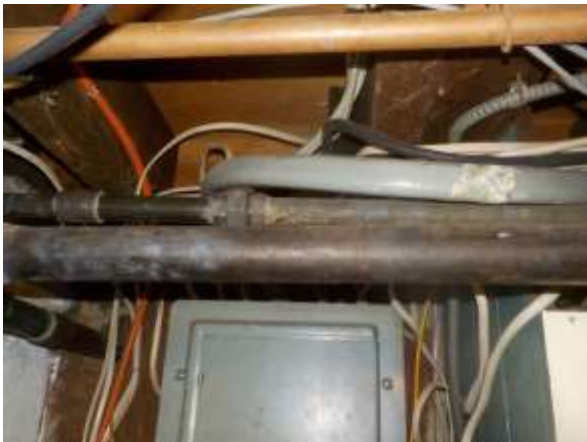
PIPES TOO CLOSE TO PANEL

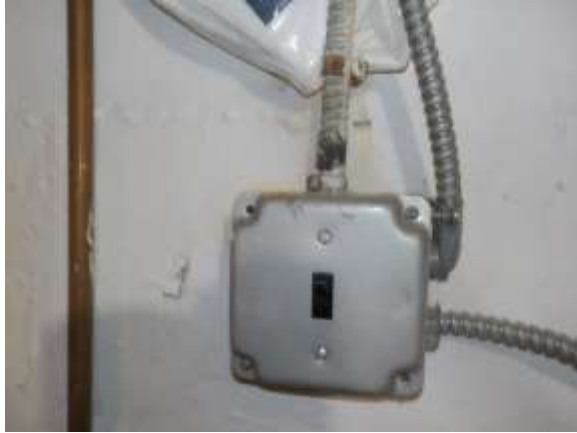
The gas-fired, 1-zone, Burnham steam boiler had no service tag on it to indicate the last time it was serviced. It is recommended that you obtain a service contract with a qualified heating company and have the unit serviced annually to extend its life. The emergency shut off switch for the heating unit is silver in color and located adjacent to the unit. The disconnect located on the staircase needs to be upgraded to a switch with a red template cover to indicate that it is the emergency switch for the boiler and to meet today's standards and so it is easily identified in the event of an emergency and not mistaken for a light switch. The gas meter is located on the east side of the exterior. All gas-fired components have shut off valves on the gas lines leading to them, including the dryer. The gas line should be upgraded to a hard pipe gas line. The insulation on the pipes should be upgraded and the material below evaluated to ensure that no asbestos is present; this is out of the scope of work for this home inspector but should be brought to your attention, an asbestos abatement company should be contacted. There is possible back-drafting occurring, the heat coming out of the front of the boiler should be evaluated. The radiant heat should be evaluated by a qualified heating professional to ensure it meets today's standards, although it was working it was inconsistent; this is out of the scope of work for this home inspector. Radiator covers are needed to avoid a scalding hazard. The home was converted from oil to gas and when this happens a special liner for the chimney should have been installed, it is essential that the chimney is evaluated to ensure it has been properly lined for the conversion to avoid a potential fire hazard. At one time there was an underground oil storage tank on the property; as per owner the tank has been abandoned and is in possession of the abonnement certificate; this certificate should be verified and transferred over to you. Any hidden defects are the sole responsibility of the potential home buyer, this inspection is based on visual access only. A qualified heating company should be contacted to inspect the entire heating system and to make all needed repairs and upgrades for you.

EMERGENCY SHUT OFF SWITCH

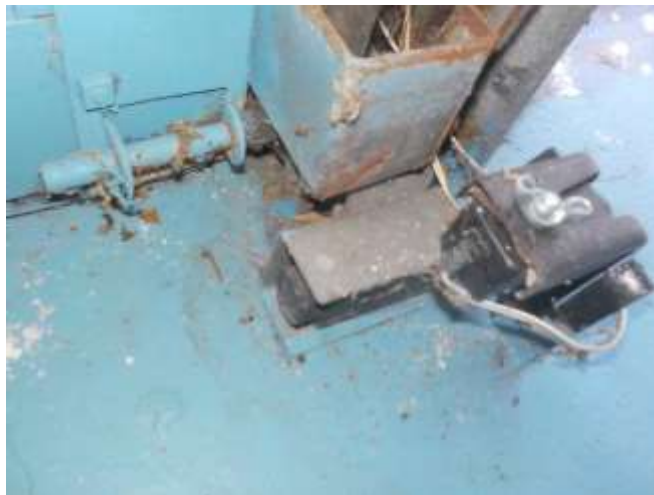
A self-closing, fire-rated door is needed between the garage and the laundry room for added protection and to meet today's standards. Standard size 5/8-inch fireproof sheet rock should be installed between the living space and the garage to meet today's fire codes. The electric eye system on the bottom of the west door did not work and it is too close to the ground, it should be raised up no more than 6 inches from the ground; this is a safety hazard in its current condition. The east side garage door retracts by itself at certain points, repair is needed. There is a gap below the foundation on the west side; a structural engineer should be contacted. Any cracks should be patched. There are gaps below the garage doors, new weather stripping should be installed below both doors to avoid water or rodent entry. The French drain should be cleaned out for maintenance. It is suggested that a sump pump also be installed. Any hidden defects are the sole responsibility of the potential home buyer, this inspection is based on visual access only. A licensed contractor should be contacted to make all needed repairs and upgrades for you.

ELECTRIC EYES DO NO WORK

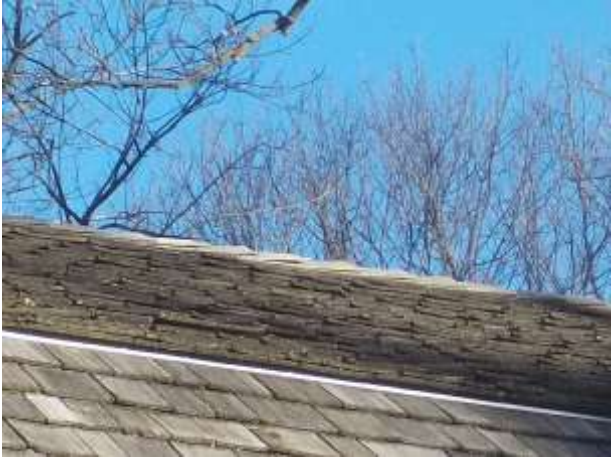
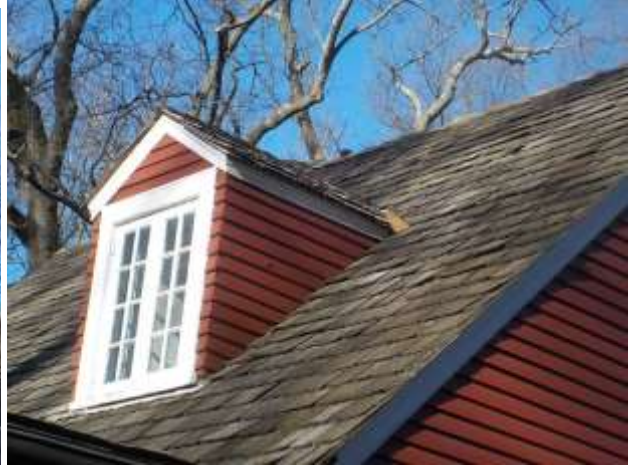
The existing homeowner should transfer any existing warranties to the potential home buyer. The roof may soon reach its useful life. There is moss growing on the top south side and north side of the roof; this is an indication that the roof is holding moisture in these areas. The wood shingles on the entire roof are old and curled; they should be evaluated by a roofing professional. Flashing is needed where the sections of roof meet including the upper and lower southeast side to avoid water penetration. There are multiple exposed nails on the wood roofing shingles that need to be covered to avoid leakage. The trees overhanging and touching the home need to be trimmed to avoid insect intrusion and roof deterioration from occurring. A larger plumbing vent stack pipe is needed on the northeast side to allow adequate air flow to all plumbing components. The gutters need to be cleaned out of all debris to avoid water from overflowing and pooling at the foundation base, gutter guards should be installed to avoid future debris from building up. Longer gutter leaders are needed from the upper gutter leader to the lower gutters to avoid staining to the roof. The gutter leader on the northeast side needs to be secured. Any hidden defects are the sole responsibility of the potential home buyer, this inspection is based on visual access only. A qualified roofing and gutter company should be contacted to make all needed repairs and upgrades for you.

MOSS AND CURLED SHINGLES

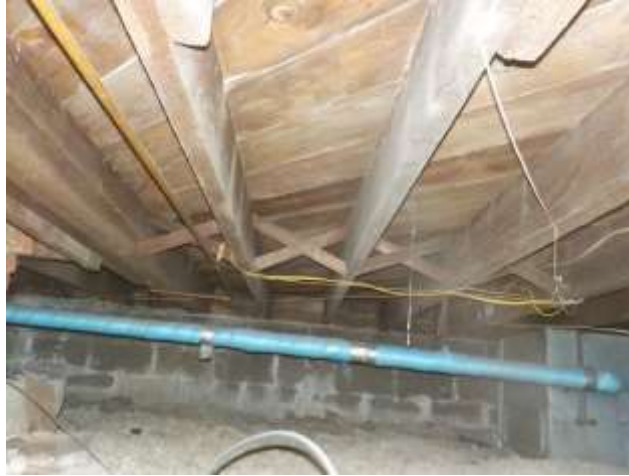
conditions, multiple repairs are needed. A vapor barrier is needed in the crawlspace to avoid moisture from rising. The crawlspace needs to be insulated on the south side. There was limited access to the crawlspace and possible concealed defects may be present. Any hidden defects are the sole responsibility of the potential home buyer, this inspection is based on visual access only. A licensed contractor should be contacted to make all needed repairs and upgrades for you.

CRAWLSPACE NEEDS INSULATION AND OXIDIZED PIPES

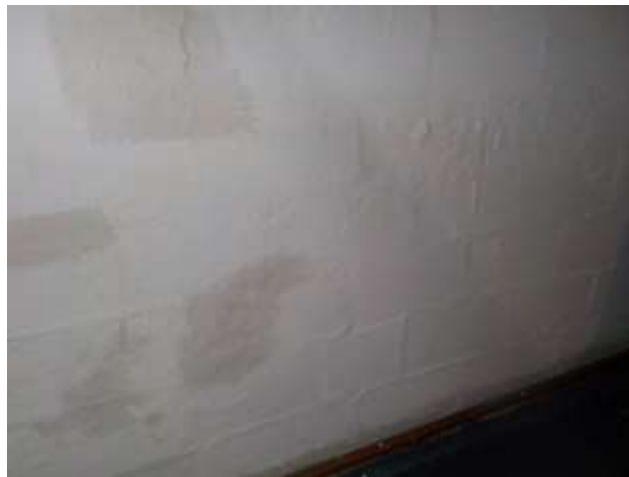
EFFLORESCENCE

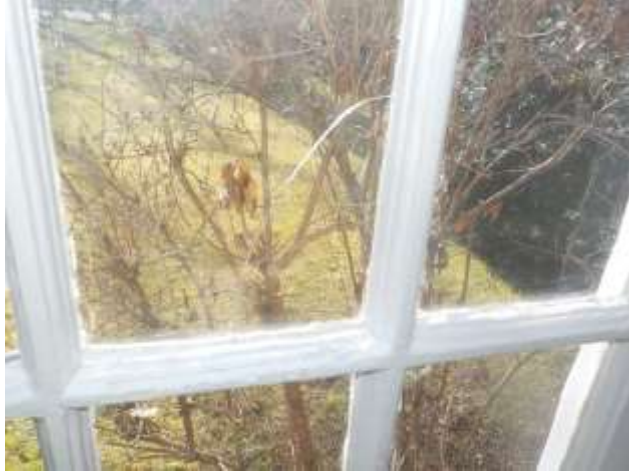
BROKEN WINDOW

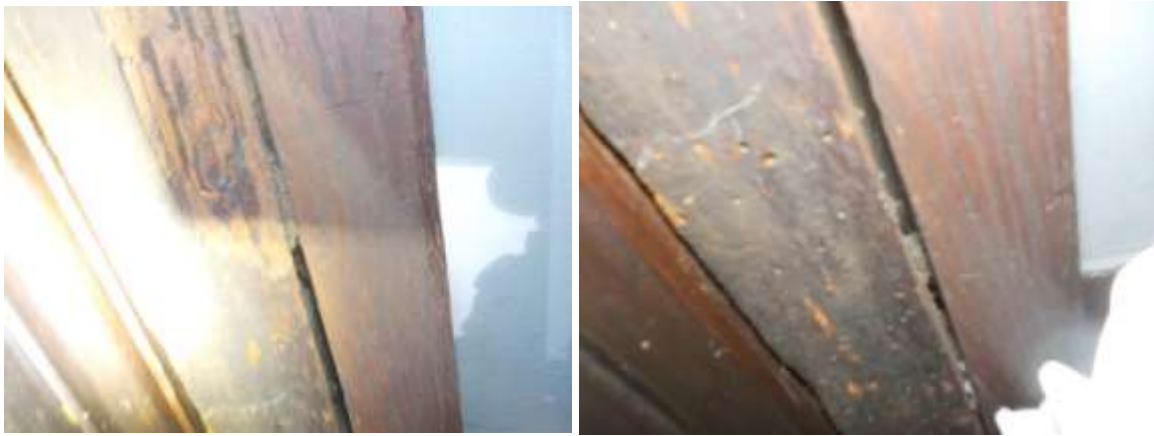
5. The hot water heater may soon reach its useful life.
6. The roof may soon reach its useful life.
7. There is a termite infestation and damage in the crawlspace and possible wood boring beetle damage in the master bedroom wood framing (verification needed); treatment and guarantee are needed.

WOOD BORING BEETLES

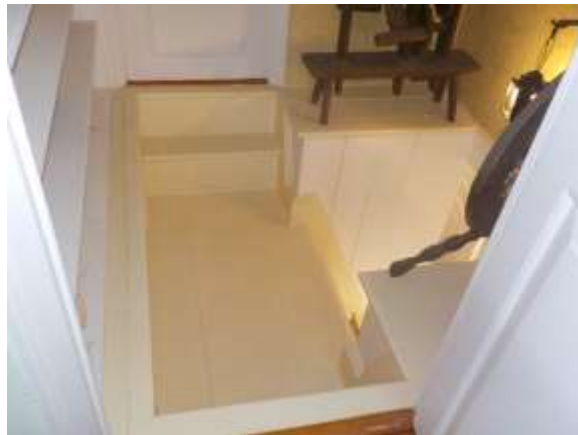
SAFTEY HAZARD

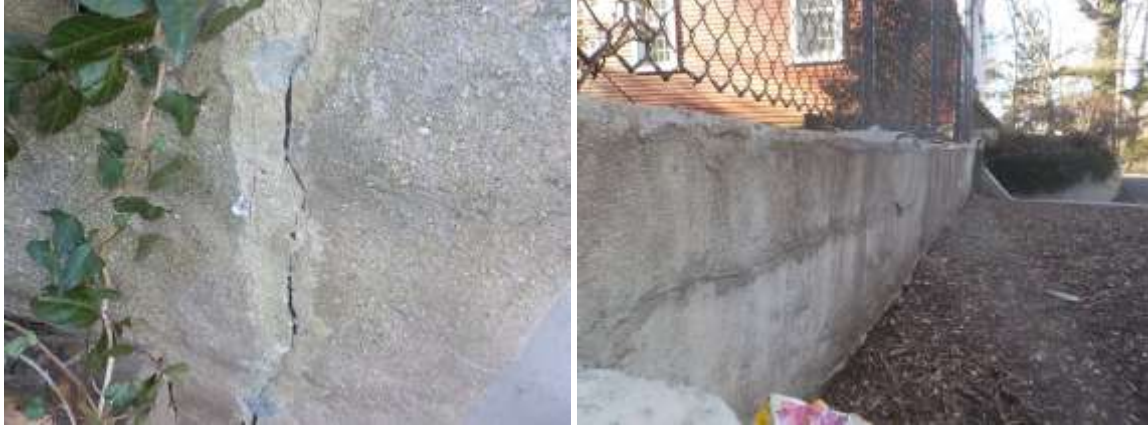
The retaining walls throughout the entire exterior of the home are cracked and bowing and in overall poor condition including (two locations on the north side and two locations on the northeast side). The stone retaining wall on the west side needs to be replaced. Furthermore, it is suggested that a retaining wall be installed on the west side of the driveway. A structural engineer should be contacted, multiple repairs are needed for the retaining walls. Regrading is needed for all gardens that are sloping towards the home to avoid water from pooling at the foundation of the home that could then penetrate inside. There is water damage to the northwest side door frame; it should be replaced and then properly capped. There are cracks to the driveway, new drainage is recommended in a minimal of two locations on the driveway even though one is present. The stoop is sloping on the northwest side. A railing is needed for the east side staircase. Any ivy, trees and/or bushes that are touching the home need to be trimmed to avoid insect intrusion. Window well covers are needed for all basement windows to avoid water intrusion, gravel should be placed at the bottom of the wells to absorb any additional water. There is a crack to the window well on the west side. Frost free hose bibs are recommended to avoid the pipe from freezing in the winter months. Multiple repairs are needed around the exterior. Any hidden defects are the sole responsibility of the potential home buyer, this inspection is based on visual access only. A licensed contractor should be contacted to make all needed repairs and upgrades for you.

CRACKS TO RETAINING WALL

1. Retaining walls are needed around the entire exterior; the existing retaining walls need to be repaired, a structural engineer should be contacted.
2. It is suggested that an additional sump pump be installed on the lower level of the home.
